## TOMOS A 35

workshop manual

TOMOS  
TWO WHEELERS & COMPONENTS  
PRODUCTION, SLOVENIJA

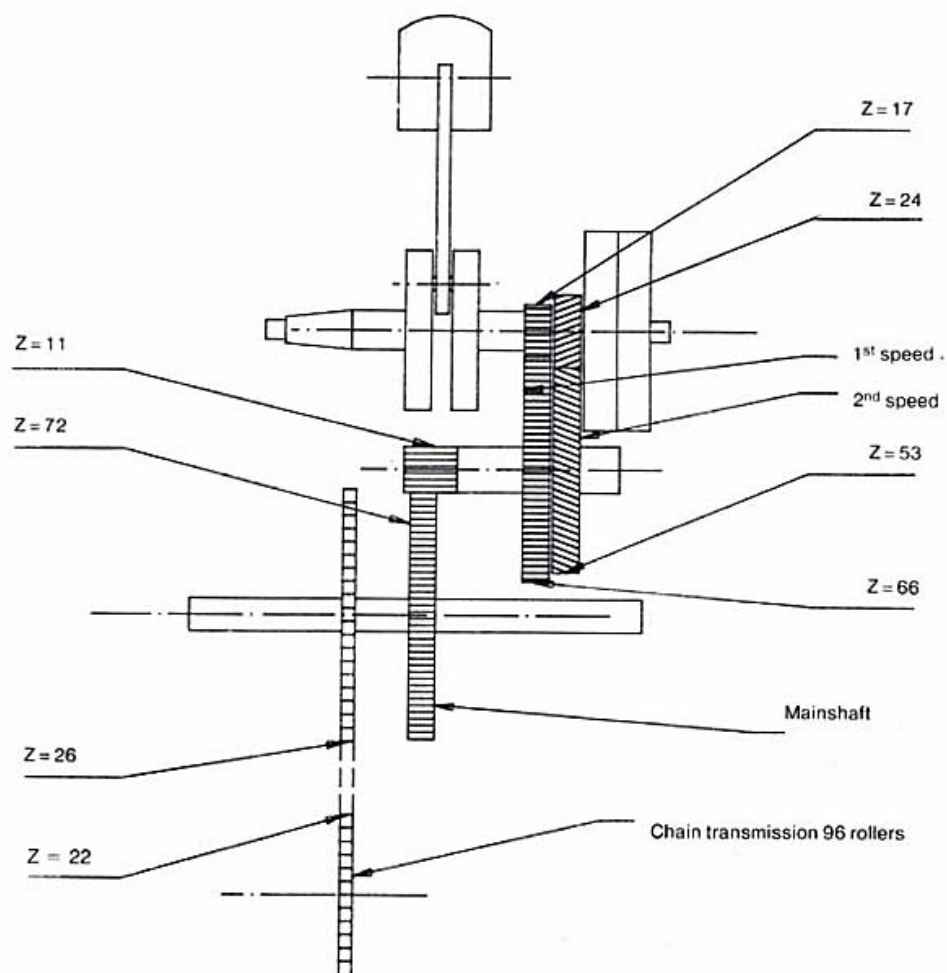
## TRANSMISSION

| Gear ratio 1 <sup>st</sup> speed | $(66/17)$ | $i = 3.8823$ |
| Gear ratio 2 <sup>nd</sup> speed | $(53/24)$ | $i = 2.4615$ |
| Gearbox ratio 1 <sup>st</sup> speed | $(3.88 \cdot 72/11)$ | $i = 25.4117$ |
| Gearbox ratio 2 <sup>nd</sup> speed | $(2.46 \cdot 72/11)$ | $i = 16.1189$ |
| Chain transmission ratio | $(22/26)$ | $i = 0,846$ |
| Total transmission ratio 1 <sup>st</sup> speed | $(25,4117 \cdot 0,846)$ | $i = 21.502$ |
| Total transmission ratio 2 <sup>nd</sup> speed | $(16.11/0.846)$ | $i = 13.631$ |

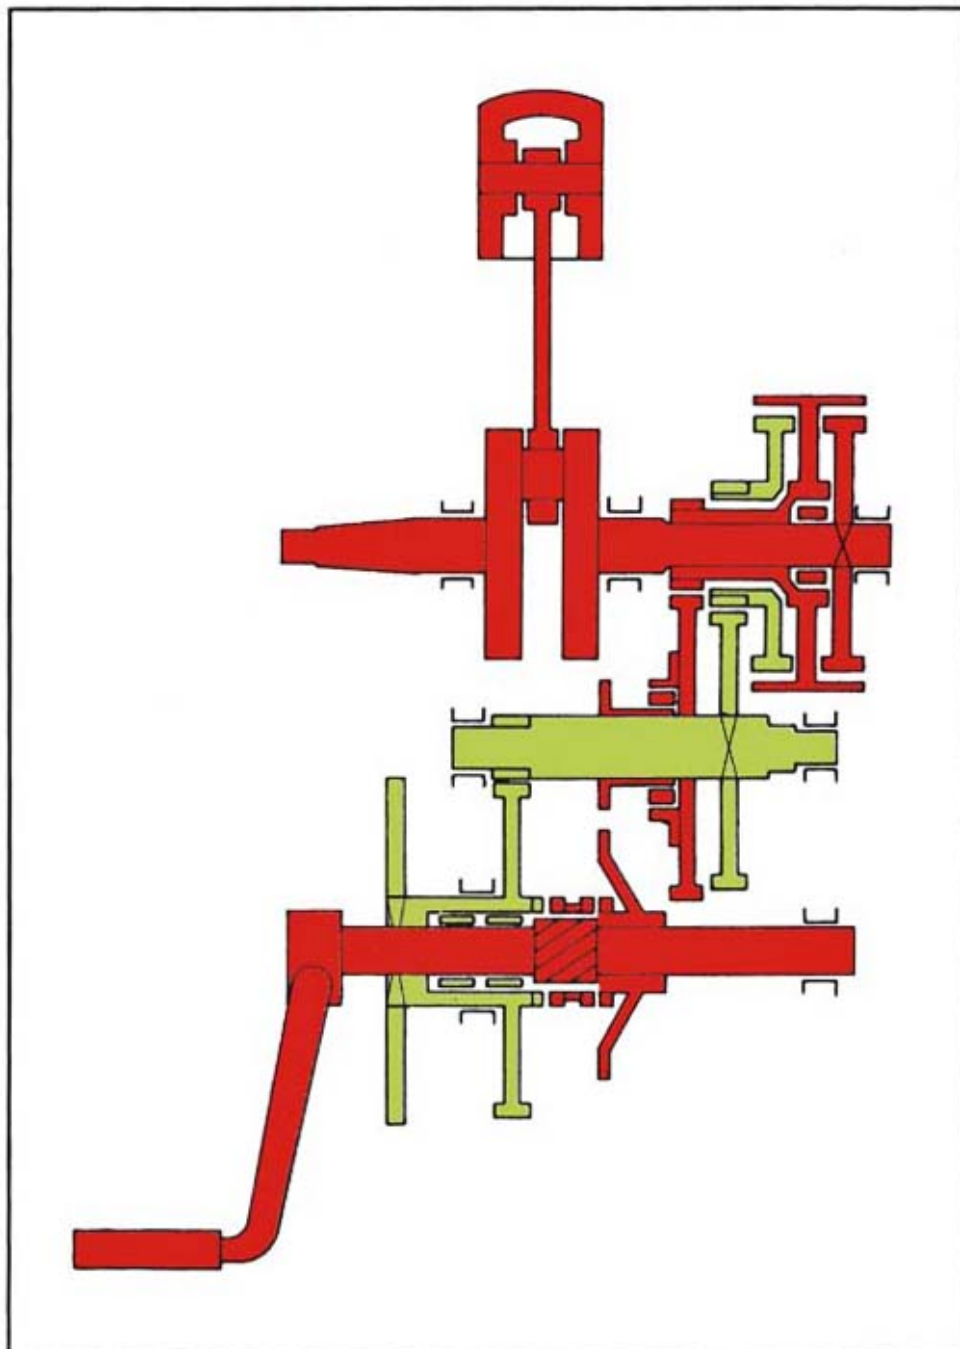
Starting

- rotating powered elements
- free rotating elements
- stand still elements

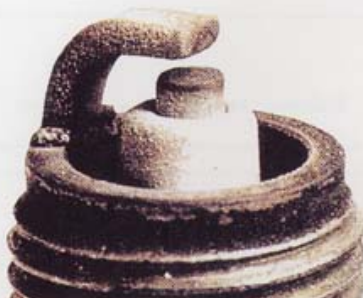
A brown, tan or gray firing end is indicative of correct engine running conditions and the selection of the appropriate heat rating plug.

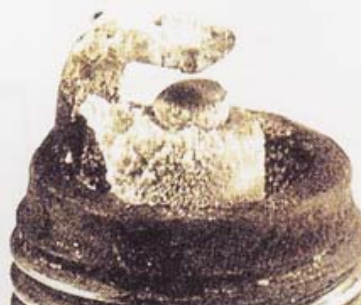
White deposits have accumulated from excessive amount of oil in the combustion or through the use of low quality oil. Remove deposits or a hot spot may form.

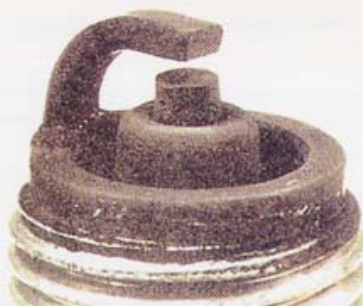
Black sooty deposits indicate an over-rich fuel /air mixture, or a malfunctioning ignition system. If no improvement is obtained, try one grade hotter plug.

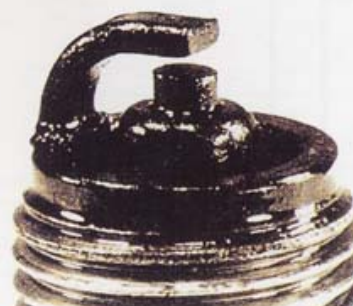
Wet, oily carbon deposits form an electrical leakage path along the insulator nose, resulting in a misfire. The cause may be a badly worn engine or a malfunctioning ignition system.

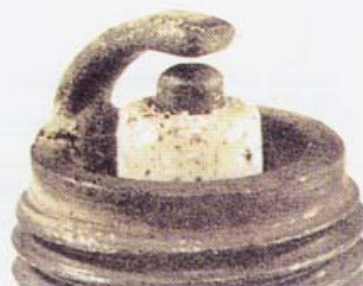
A blistered white insulator or melted electrode indicates over advanced ignition timing or a malfunctioning cooling system. If correction does not prove effective, try a colder grade plug.

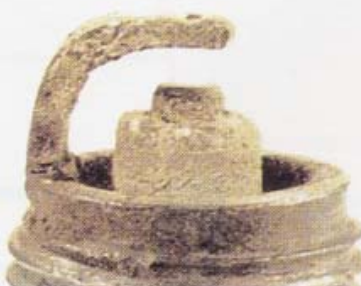
A worn spark plug not only wastes fuel but also overloads the whole ignition system because the increased gap requires higher voltage to initiate the spark. Adjust spark plug gap or replace.

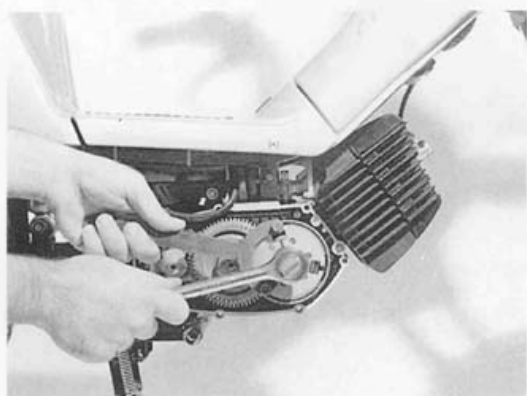
Fig. 1

Slacken the protective clutch washer with a socket 19 and with special tool 732.202 remove 1<sup>st</sup> speed clutch nut (fig. 1).  
Detach clutch drum by hand or by means of an standard extractor in case of bushing seizure (fig. 2).

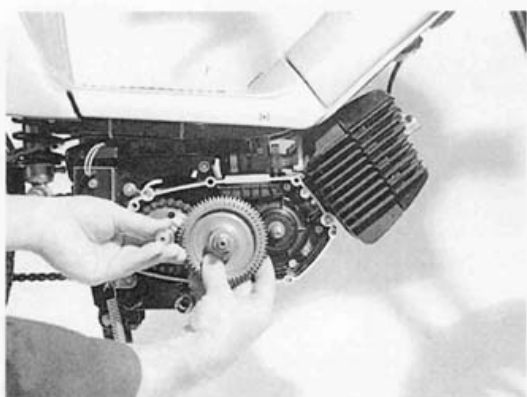
Fig. 3

The starter shaft and the countershaft are connected by a starter chain, so both shafts will have to be taken out together (fig. 3).  
Remove the standard washers on the crankshaft and on the mainshaft (fig. 4).

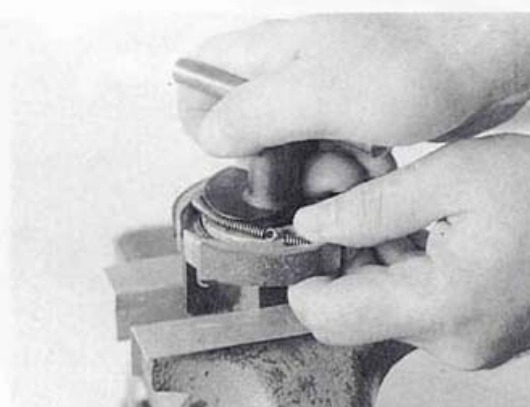
**Fig. 6**

Fix the main pin of the device 737.535 with the thinner part facing upwards. The spring joint must be placed in the middle of one shoe. With the lever of the device insert the spring in the shoes groove. (Fig. 6).

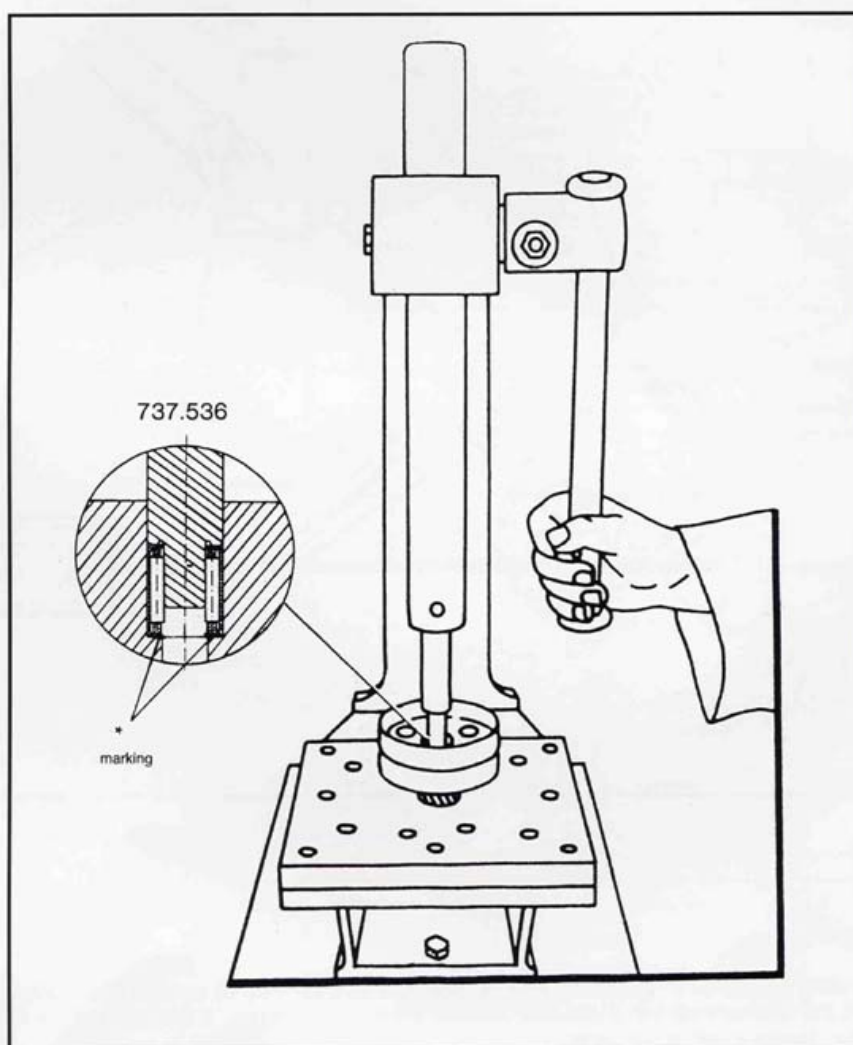
Fig. 7

A new needle clutch is pressed with special tool no. 737.536 (Fig. 7).

The needle clutch must be pressed with the signed side towards the center of the clutch drum, if not it may operate in the reverse direction.

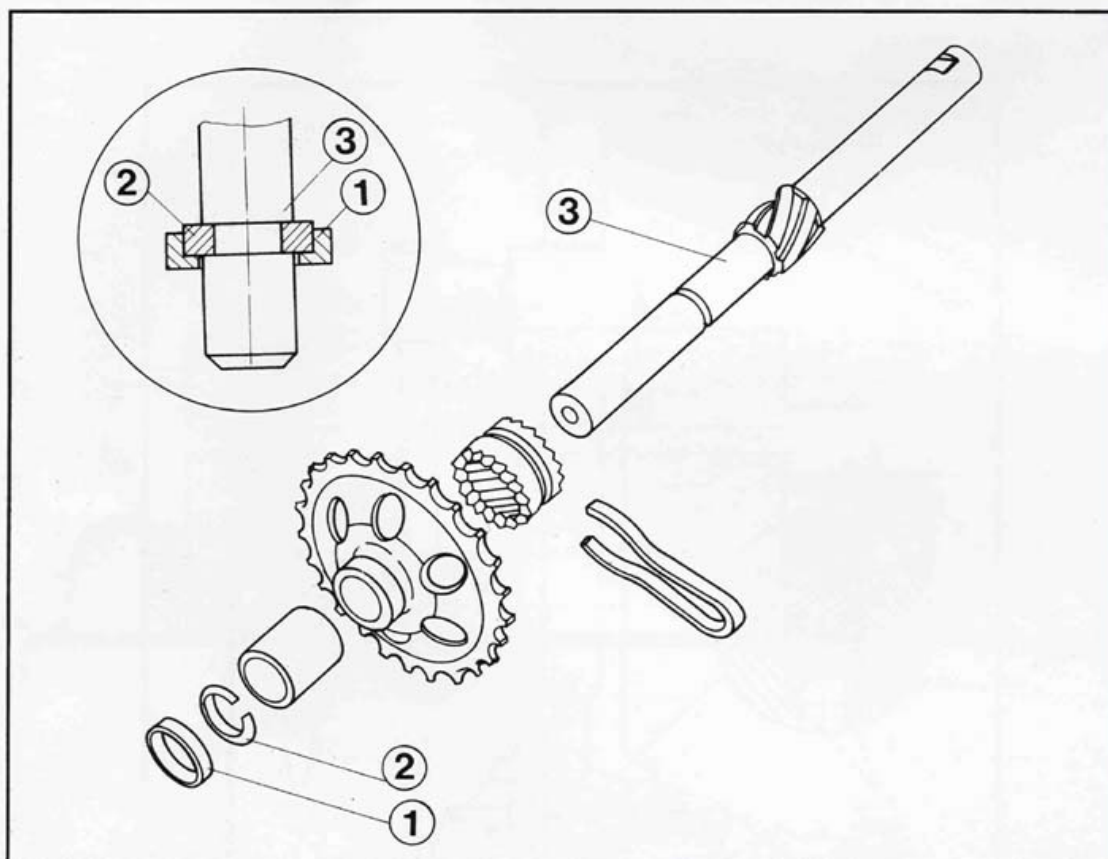
Fig. 8

If is necessary to replace chain sprocket or claw collar on pedal shaft of kick shaft, first remove protective ring (fig. 8/1) and spring washer (fig. 8/2). During assembly take care that the thinner part of collar is mounted forward or else, the brake spring slides across the chain sprocket. Check the chain for overtension or some other damage.

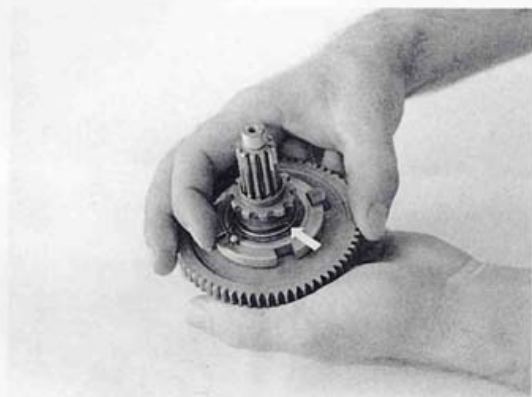
Fig. 9

Use of grease is not suggested because it may impede the function of the selflocking clutch. Put the chain sprocket with cage so that the beginning of wire spring is turned 90° left-ward from spring nose. (fig. 9). Lock the wire spring to riveted nose on the selflocking clutch body.

Remove and inspect the 1<sup>st</sup> speed driven gear selflocking clutch in case of transmission troubles mentioned on page 24. Remove the sg-circlip at the countershafts toothing. Unfasten the wire spring (Fig. 9) and separate a small chain sprocket with roller cage. Remove the selflocking clutch and the rollers (Fig. 10).

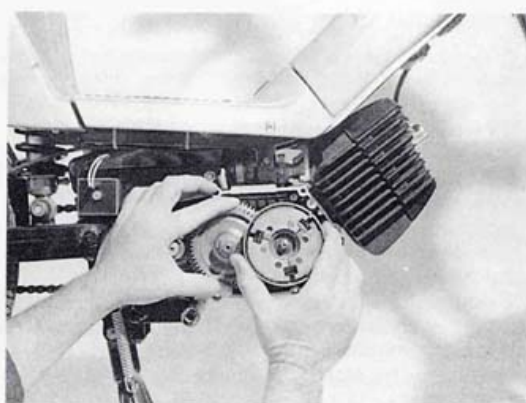
Fig. 11

Before tightening nut, it is necessary to check the proper function of the assy. Firmly hold 2<sup>nd</sup> speed driven gear with the left hand and the clutch drum with the right hand. When clutch drum rotates counterclockwise, both clutches idle, when it rotates clockwise the motion is transmitted to the crankshaft (fig. 11).

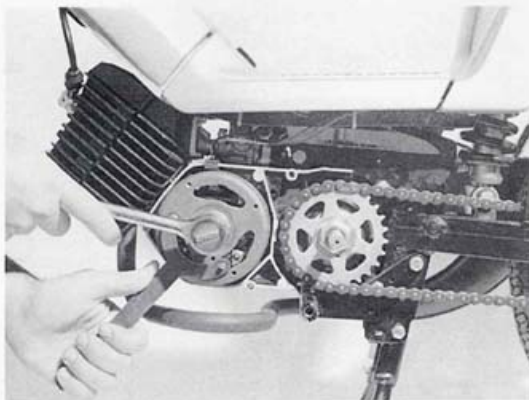
Fig. 12

- starting/lever pedal (wrench 11, plastic mallet)
- side protection shield fixed on swinging arm (wrench 10)
- engine cover (flat screwdriver)
- flywheel nut (socket wrench 17, flywheel holder=special tool 732.202=fig. 12)
- flywheel (wrench 32 and 19, flywheel extractor=special tool 732.746=fig. 13)
- stator plate (flat screwdriver)

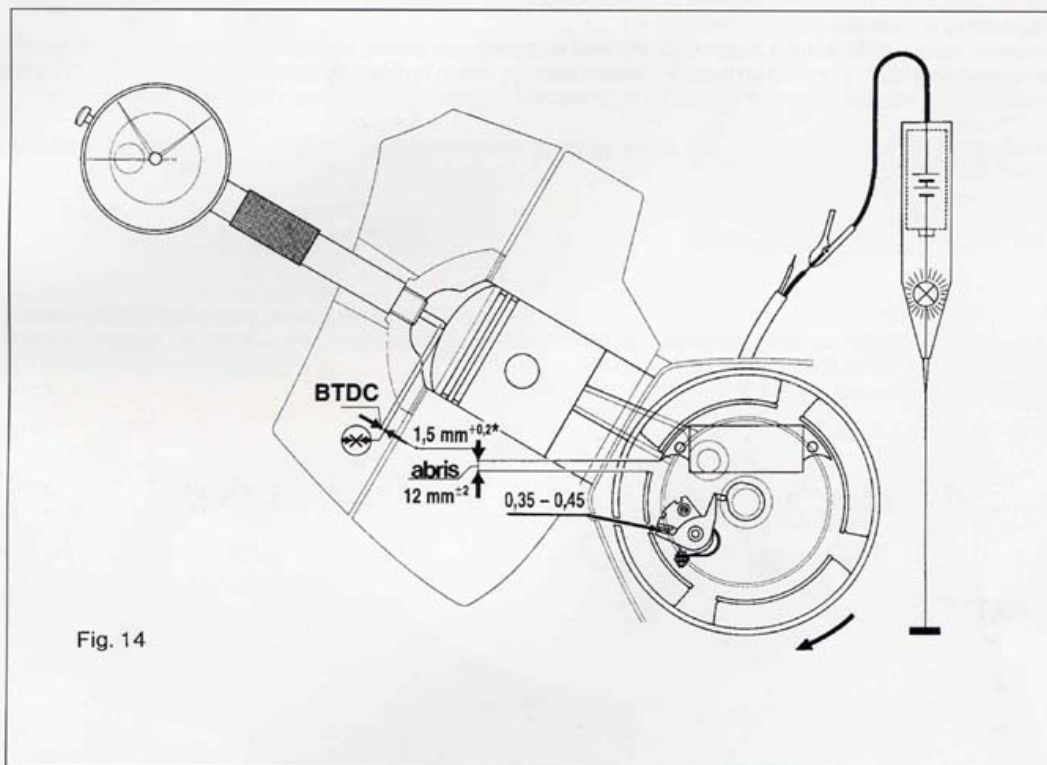
Fig. 14

For proper function of the engine is essential a correct ignition timing. The ignition advance should be  $1,5 \pm 0,2 \text{ mm}^*$ . The most common cause of incorrect timing is due wear or damage of contact breaker points, wear of cam actuated breaker nose lever, damage of condenser. To provide the exact timing is necessary to replace faulty parts and proceed (fig. 14) as follows:

- Screw the special tool 732.193 and dial gauge 975.709 with gauge pin 011.008 into the spark plug hole. By rotating the flywheel put the piston to the T.D.C. and set the dial gauge to zero.

- With the flywheel in T.D.C. set the contact breaker points gap between 0,35 to 0,45 mm
- With a test light, buzzer or Ohm meter determine when contact breakerpoints connection is made. The testing device must be connected to the short circuit (black) wire and to the ground of the engine. At the moment of connection of the points the test battery light will glow brightly, the buzzer will change the acoustic frequency or the Ohm tester will show approx. zero Ohms.

- Rotate the flywheel in the clockwise direction until the dial gauge will show the value of 1,5 mm
- By means of oblong fixing openings rotate the stator base plate and find a contact breaker points connection - opening position (test indication).

- Tighten the stator base plate and recheck the ignition advance which should be max. 1,7 mm
- In case of excessive advance, the stator base plate should be rotated in the direction of entire rotation (see arrow of flywheel). In case of insufficient advance turn the plate in the opposite direction.

- For efficient spark intensity or high ignition voltage is essential a proper abris adjustment. As a matter of fact, it is the distance between the edge of the ignition coil pole shoe and the receding magnet pole edge at the opening point of the contact breaker and it should be within the range of  $12 \pm 2 \text{ mm}$  ( $0.473 \pm 0,079 \text{ in}$ ). The gap should be measured the moment the intensity of light or sound frequency is changed on the gauge (fig. 14).

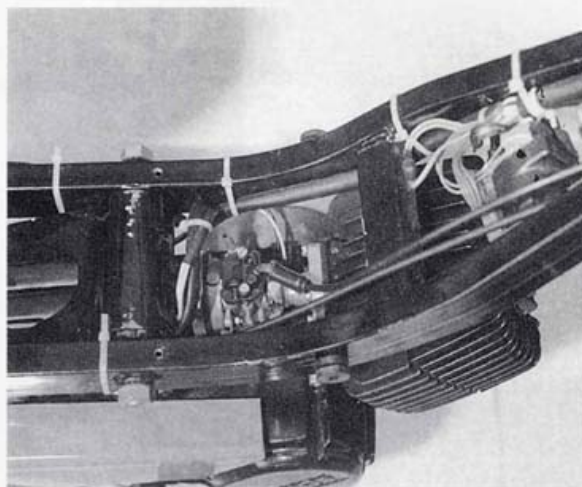
Fig. 15

- carburetor area protection shield (detach the rubber protection sheet, slackes the screwsflat screwdriver)
- fuel tank (screw on bottom side near horn attachment on frame and on rubber elements-box wrench 10 mm)
- carburetor cpl. with air filter and rubber dust protection (screw of fixing claw - flat screwdriver) fig. 15.

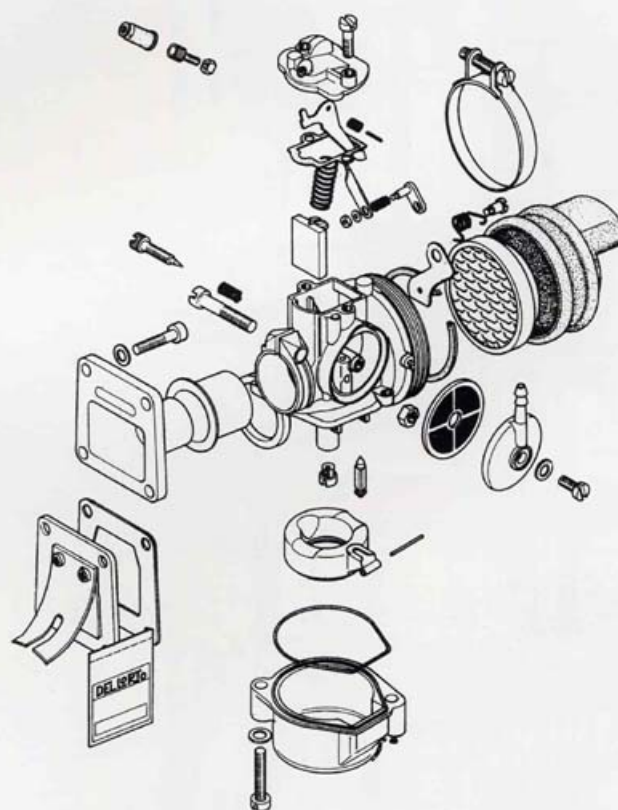
**FIG. 17**

Dismantle the carburetor into component parts (fig. 17). Clean the parts in gasoline (petrol) and blow them by compressed air.

Replace if necessary worn parts and carefully reassemble, especially the needle valve and float. Slighly oil the air filter.

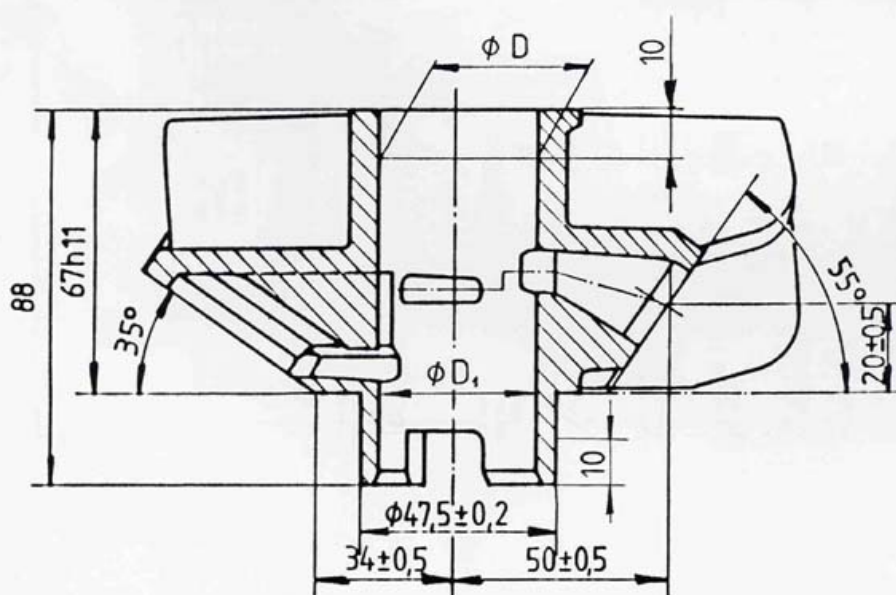
Bore taper and come-shaped:  
 $D_1 = \text{max. } 0,012 \text{ mm } (0,473 \cdot 10^{-3} \text{ in})$

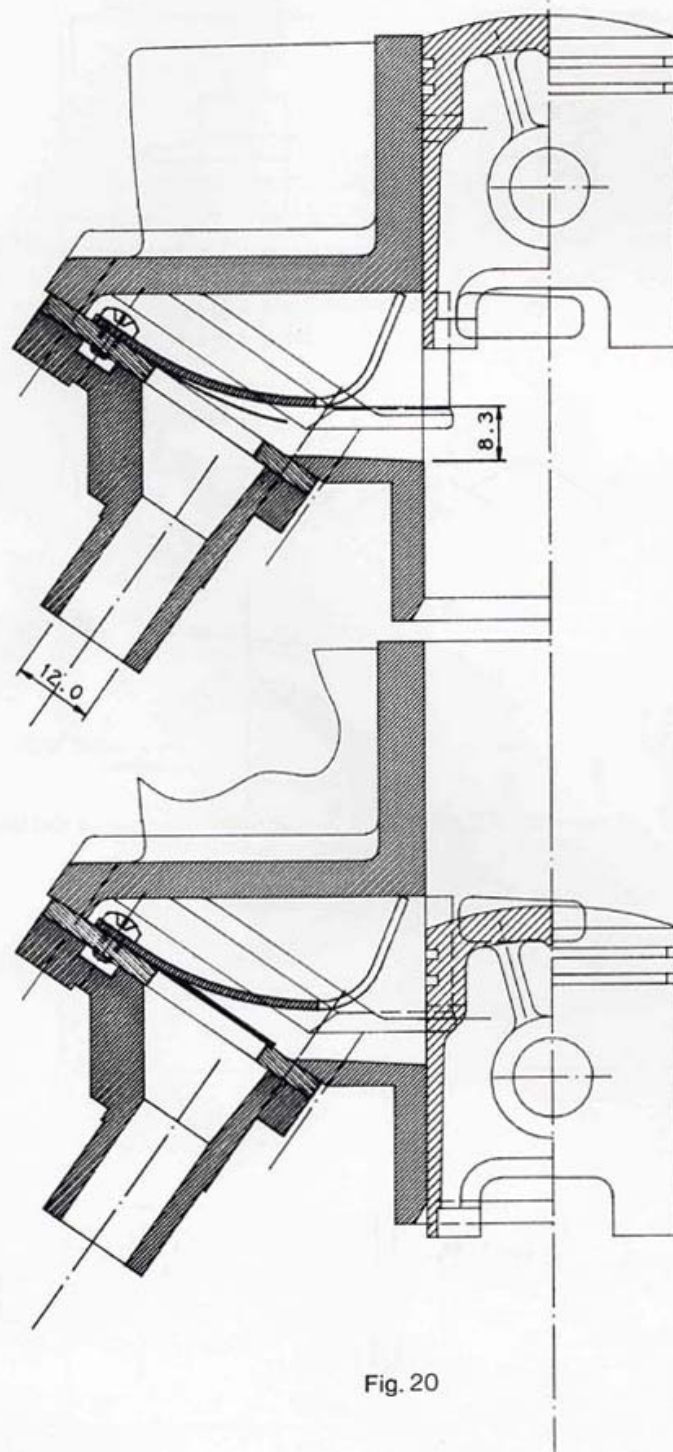
Fig. 20

Damage to reed valve may be caused also by steel material run-down (see function on fig.20, assy. parts - fig.21).

PISTON AT T.D.C.

PISTON AT B.D.C.

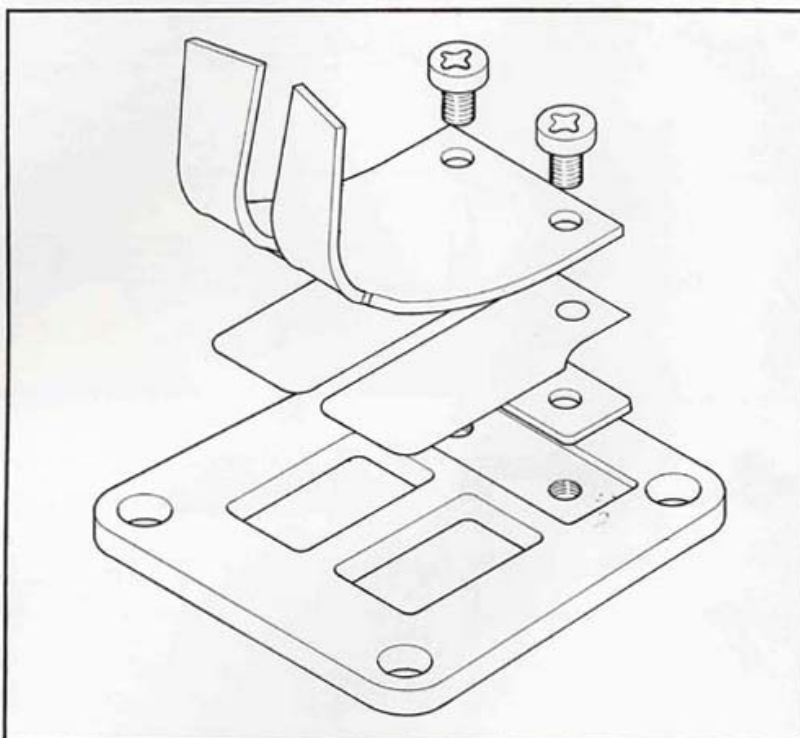
Fig. 21

**NOTE:**  
Replacement of cpl. reed valve is suggested.

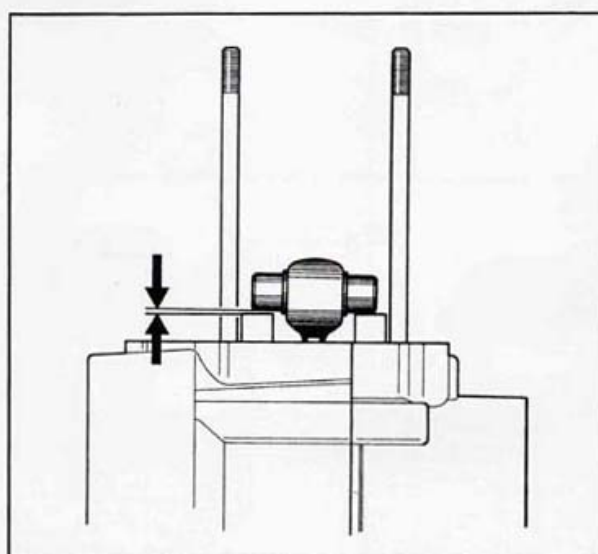
Fig. 22

Check conrod bending by help of two calippers (Fig. 22). Check the needle bearing clearance and bearing rolling surface for damage.

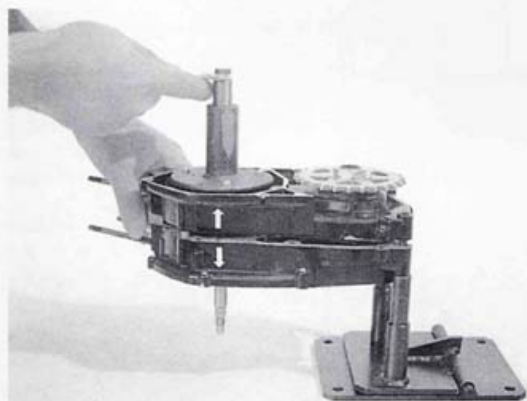
**Fig. 23**

Install on the magneto side a case splitter tool 735.888 with the three magneto base plate fixing screw. With wrench 13 mm screw on the device A and detach both halves (fig.23).

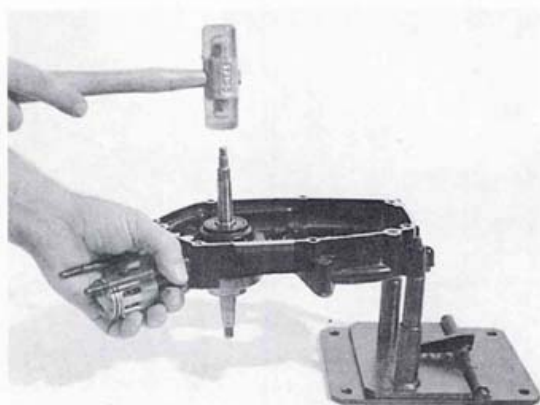
**Fig. 24**

Detach the crankshaft from the RH crankcase half with a plastic mallet (fig. 24). In case of remaining ball bearing on the crankshaft remove it with the extractor 731.155 (fig.25).

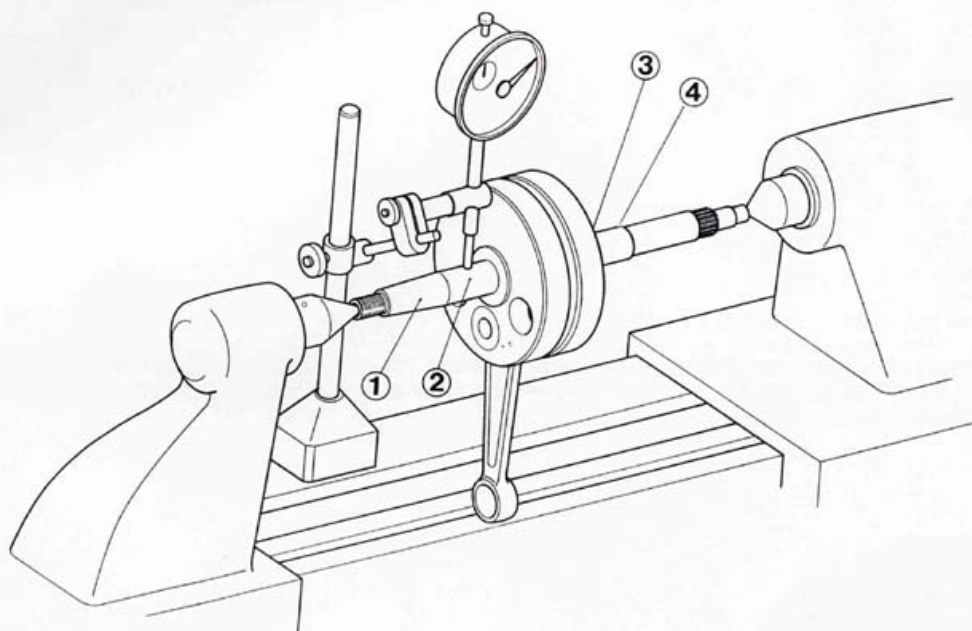
Fig. 26

Check the crankshaft between the center of a horizontal alignment tool and measure the out-of-round on all the points indicated in fig. 26.

Permissible out-of-round should be within 0.02 mm (0.008 in) at check points 2 and 0.01 mm (0.004 in) at check points 1 and 4. Check if the crankshaft conical part is damaged, inspect the thread on semiaxles and the keyway.

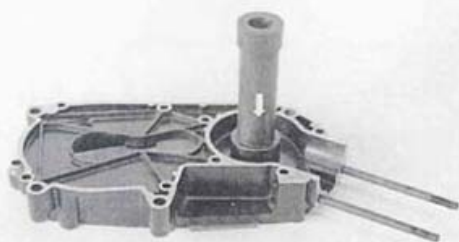
Fig. 27

Check both crankcase halves for possible damages or distortions, particularly the joint surfaces, to avoid later leaking of oil from gearbox.  
Check all bearings, if clearance is noticed, the bearings must be replaced.  
Remove seal rings by screwdriver. For disassembly of ball bearings and seal rings assembly alternatively use a pressing pin 702.856 (fig. 27 and 28).

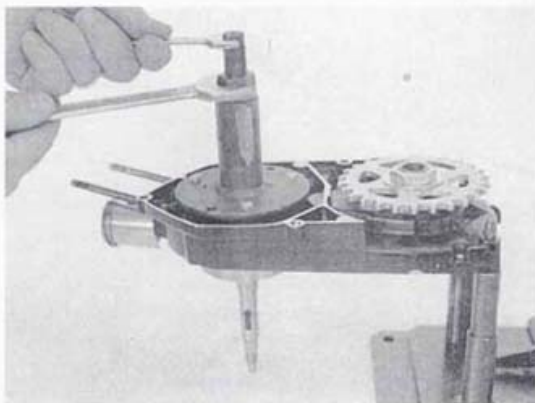
Fig. 29

Crankshaft is impressed in crankcase halves by extractor 735.888 actuating with screw B (fig. 29 and 30) - wrench 24 and 13. In case of machine press assembly is necessary a use of crankshaft insert forks 735.753 to prevent crankshaft deflection.

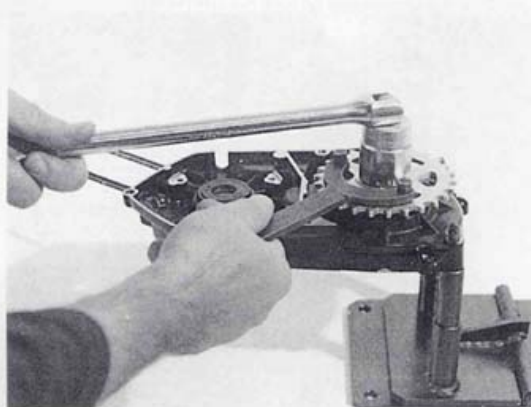
Fig. 31

In case of mainshaft toothing damage replace it. Slacken the chain sprocket nut by a wrench 30 mm and using the special tool 732.202 (fig. 31). Knock out the mainshaft by plastic mallet.

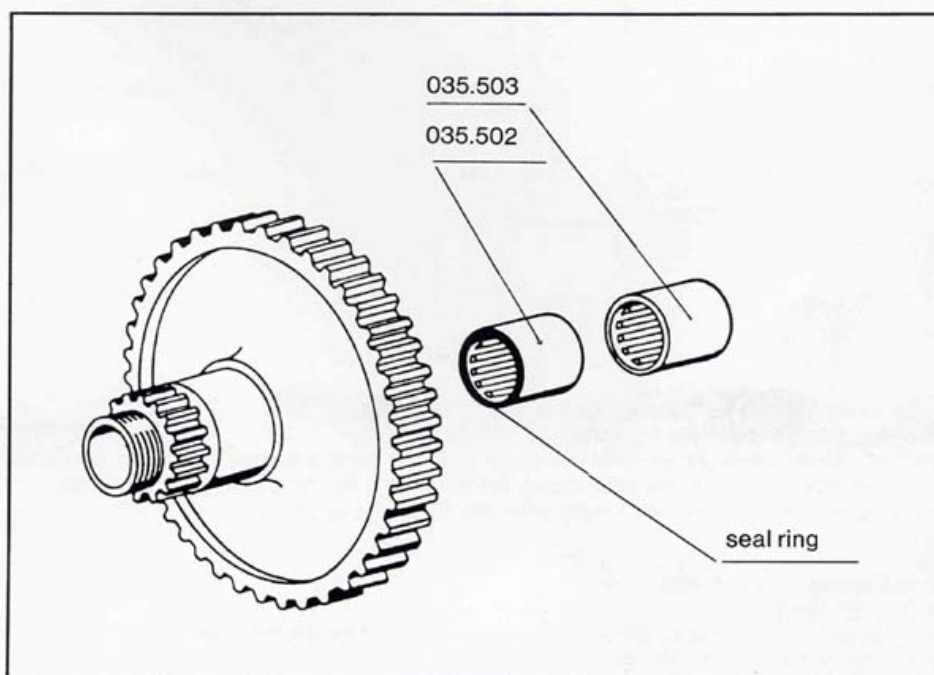
Fig. 32

In case of needle bearings or seal ring (incorporated in first needle bearing, code 035.502) damage knock out them by suitable tool but pay attention not to damage bearing lying surface on mainshaft. Pay attention on sequence assembly of needle bearings (fig. 32) by machine press tool and special tool 732.367.

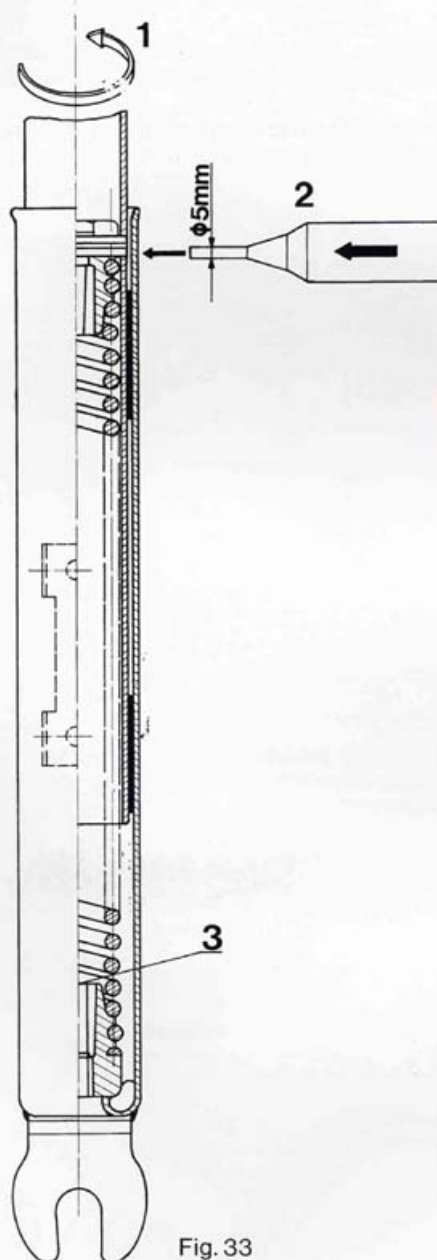
Fig. 33

The front fork lower leg can be removed as it is shown in fig. 33.

- by unscrewing remove lower leg from the front fork (fig.33/1)
- the spring will remain attached either to the upper or to the lower screwed plug - remove by unscrewing
- the upper plug should be removed after tapping out the elastic pin (fig.33/2)
- the lower plug can be removed with longer allen key (9 mm), (fig.33/3)

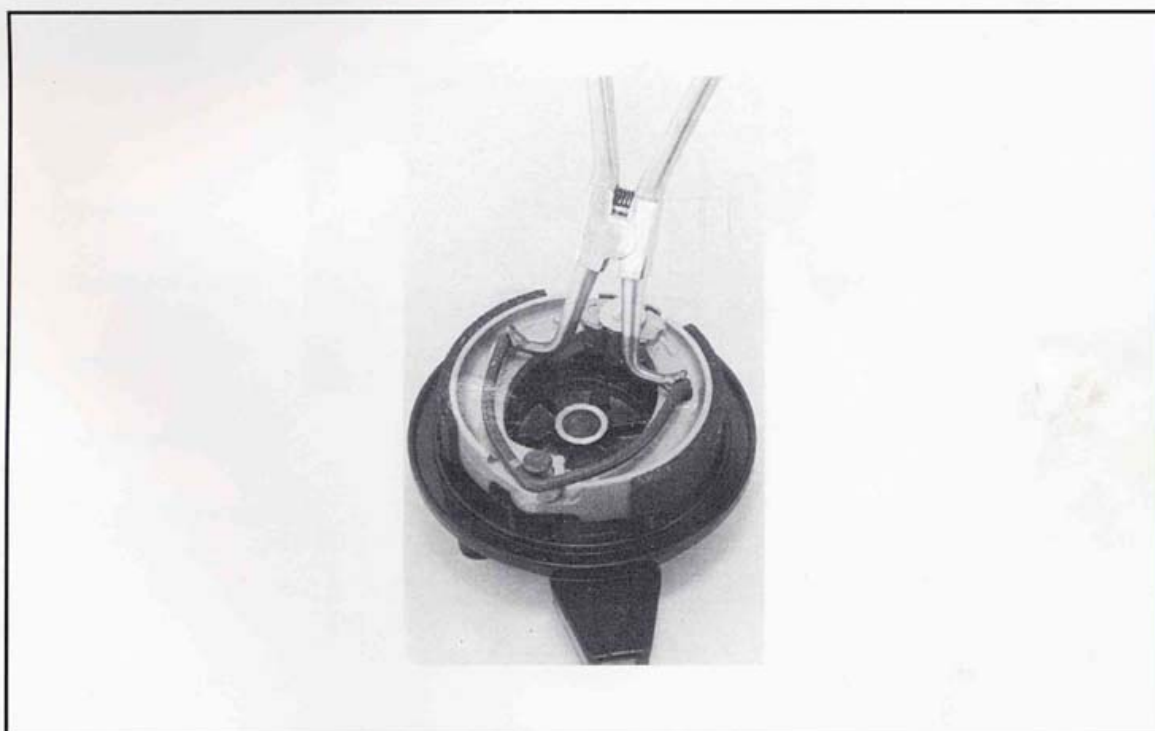
Fig. 34

Brakes are drum type (fig. 34) thus there is a periodically need of linings dust (non asbestos) cleaning; cable controls, brake operating cam and brake shoes support pin greasing. Disassembly of brake shoes is easier with pliers - special tool 736.913.

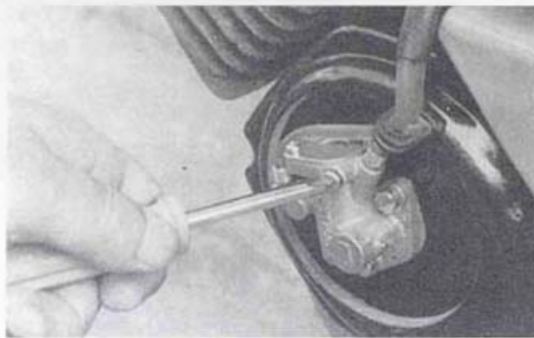
Fig. 35

- Unscrew the bleed screw on the oil pump and wait until oil from the tank under the seat flows to the pump. The screw is then screwed on (fig. 35).
- Pour approx. 1 l gas mixture in the ratio of 1:50 (2% oil) into the fuel tank and start the engine. Let the engine run of for approx. 5 min so as to make the oil pump push oil to the engine.
- Fill up the fuel tank with regular gas.
